March 1 2010

J/80 Review & Best Practices – Part II

Inspection & Repair of a 1994 J/80

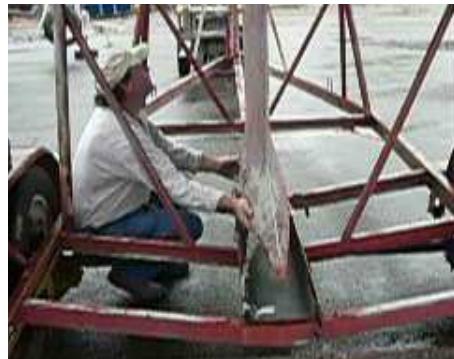
1. The boat was hoisted in a travel lift a few inches above the trailer and the **tip deflection test** conducted (Step #1). There was approx 3/8" of **tip** movement off centerline to either side (which was slightly exaggerated by the boat moving a little in the slings). However movement continued after the tip was released indicating the likelihood of damage.

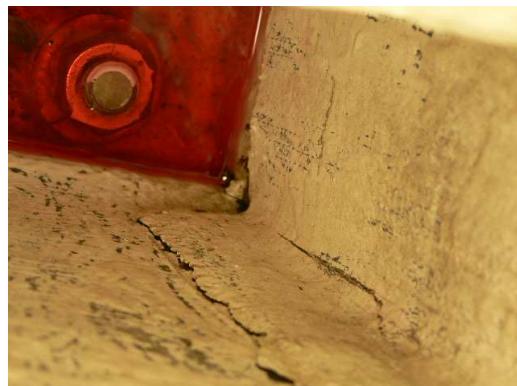
2. The same deflection test was then conducted with an observer below deck who confirmed that the fiberglass tabbing securing the three primary keel floors to the keel sump was loose from the side wall, meaning the molded sump was moving independent of the floors. A flashlight inspection of the same bilge area below decks (Step #5) revealed jagged lines along several tabbing edges – a clear sign of damage/debonding of the keel floor tabbing. The jagged tabbing did not reach up to the turn of the bilge and so there was no visible movement at the actual sump to hull intersection.

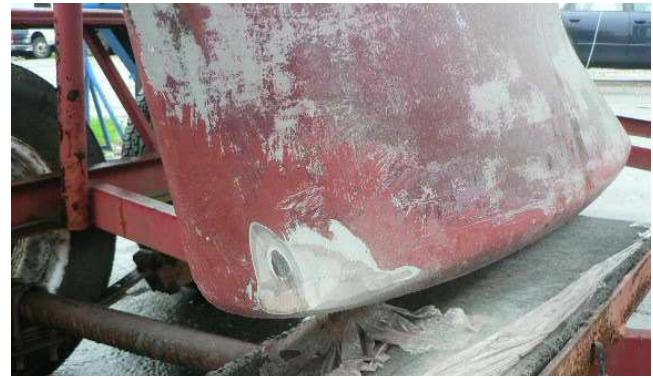
3. With various shades of paint on the bottom, there were no readily apparent cracks visible, but closer inspection of the leading edge of the keel at the hull (Step #2) revealed some small vertical cracks which appeared to be water saturated (older). The bottom front of the keel bulb was then sanded/ground back to show about $\frac{3}{4}$ " of fairing putty, presumed to be from a prior repair, since the factory-issued keel is one with minimal fairing compound on the lead bulb.

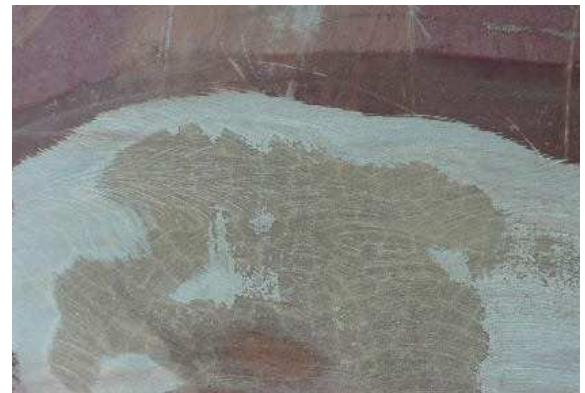
4. The fiberglass sump was then tapped/sounded out to listen for delamination or voids (Step #7). Three areas were identified as possible issues. A moisture meter confirmed that all three areas had "elevated" moisture readings. Once the bottom paint and fairing material were sanded back on the worst spot, it revealed a circular area of damaged glass (lots of white crazing) – consistent with the assumption that, without tabbing support, the sump has been working both against and independent of the keel floors for quite some time.

Marine engineering consultant John Fox (FCS Design/Team Foxy) was then retained to specify the repair to be carried out by International Marine in Bristol, RI. Because there was damage to both the interior and exterior of the sump, the interior was first repaired in order to fully stabilize the area. All paint was removed in the bilge area, and then all keel floor tabbing ground away; several layers of biaxial glass were laid in to reattached the keel floors. The exterior was then repaired - the crazing areas were ground back and repaired with biaxial glass followed by surface fairing material and paint. A subsequent tip deflection test resulted in near zero deflection (not measurable), and International Marine issued a 5 year structural warranty on the repair, which cost a total of \$2,800. Had the damaged tabbing been discovered earlier in the boat's life, then exterior damage would likely have been minimized or avoided and the repair costs would have been considerably lower.

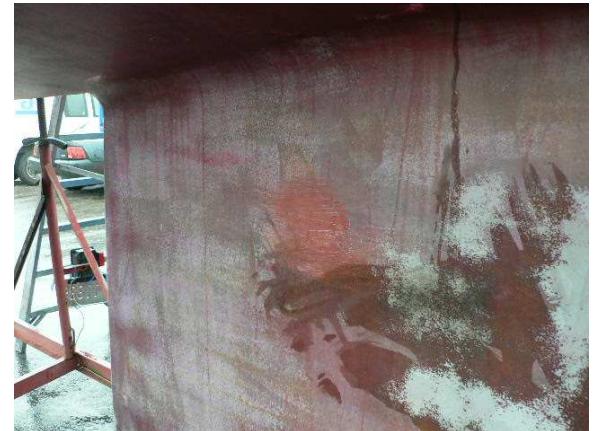
Another suspect spot was covered in splotched red paint (same color as the paint on the bottom/front of the keel). This area was sanded back to reveal different fairing compound than neighboring areas, and beneath that more glass crazing and some delamination of the belly band (the cosmetic glass wrap that hides the seam between the lead and the sump bottom). The belly band is nonstructural but it appeared that water had penetrated the seam at some point and likely froze over a few cold New England winters. It was later confirmed that the yard that did the original keel fairing work in the 90s had ground off the original standard belly band as well as all the gelcoat on the sump.
